Tribocorrosion properties of metallic materials and effects of metal release

Ph. D. Thesis

August 2007

Department of Manufacturing Engineering and Management
Technical University of Denmark (DTU)
DK - 2800 Kgs. Lyngby.

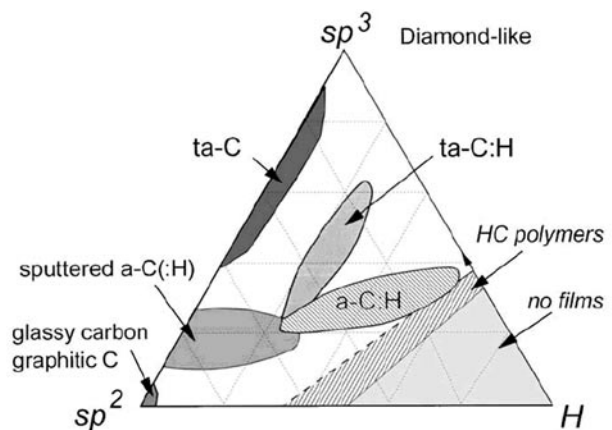
Figure 3—Various forms of bonding in C-H alloys presented in a ternary phase diagram.¹¹

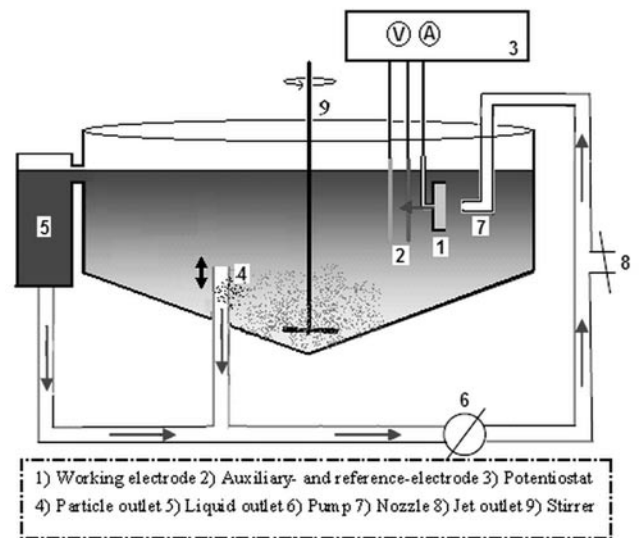
Figure 5—Erosion-corrosion experimental setup.

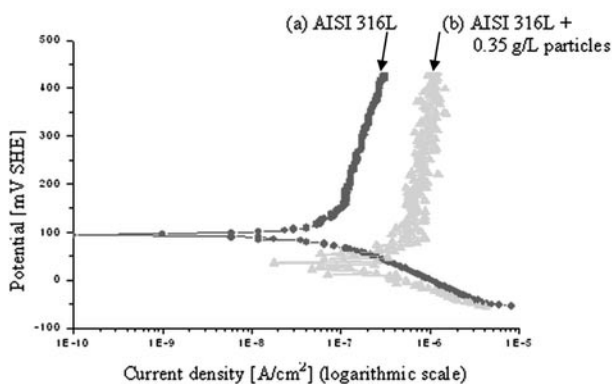
Figure 6—Polarization curve at a scan rate of 1 mV/sec for stainless steel AISI 316 L in 0.03 wt% chloride, 0.1M acetate buffer at pH 5.5 with (a) erosion 0.35 g/L, 250- μm alumina particles and (b) without erosion.

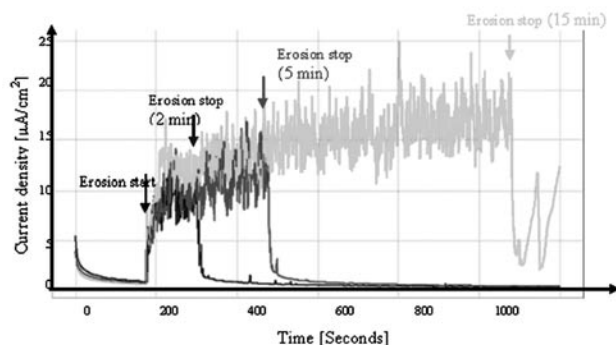
Figure 7—The resulting current at a fixed potential of $644 \text{ mV}_{\text{SHE}}$ has been monitored for untreated AISI 316 L. Three erosion time durations were studied: 2, 5 and 15 min. The solution was 0.05M sodium citrate/citric acid buffer at pH 4 with a NaCl concentration of 0.5 wt% and 0.5 g/L 250- μm alumina particles.

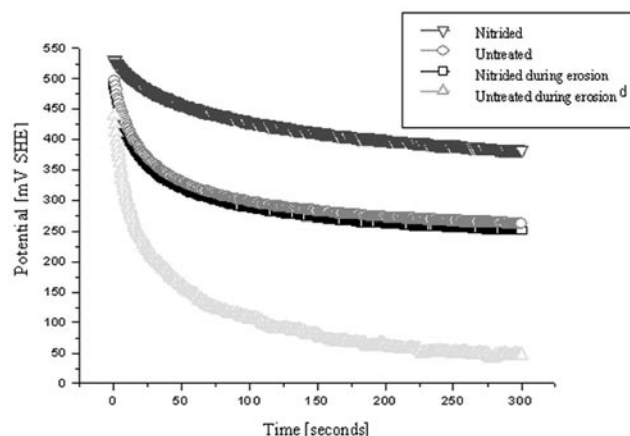
Figure 8—Open circuit potential for AISI 316 L and low temperature nitrided AISI 316 L in 0.03 wt% chloride, 0.1M acetate buffer at pH 5.5 with and without erosion of 0.35 g/L, 250- μm alumina particles.

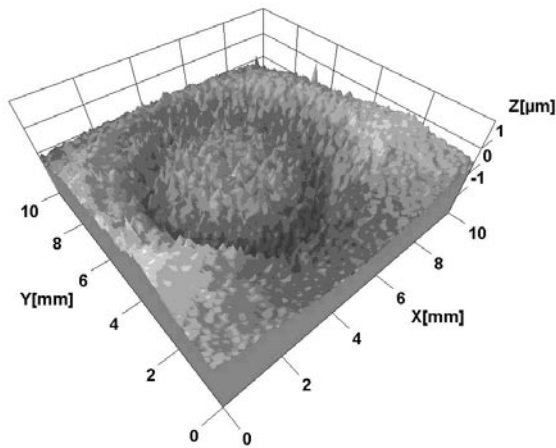
Figure 9—Surface topography made by nondestructive laser measurement of DLC-coated AISI 316 L after erosion-corrosion in 0.05M sodium citrate/citric acid buffer at pH 4 with a sodium chloride concentration of 0.5 wt% and 0.5 g/L 250- μm alumina particles.

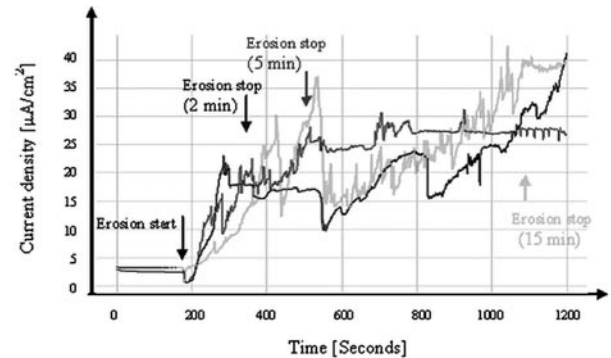
Figure 10—The resulting current of the DLC coating has been monitored at a fixed potential of $644 \text{ mV}_{\text{SHE}}$ for three erosion time durations: 2, 5 and 15 min in 0.05M sodium citrate/citric acid buffer at pH 4 with a sodium chloride concentration of 0.5 wt% and 0.5 g/L 250- μm alumina particles.

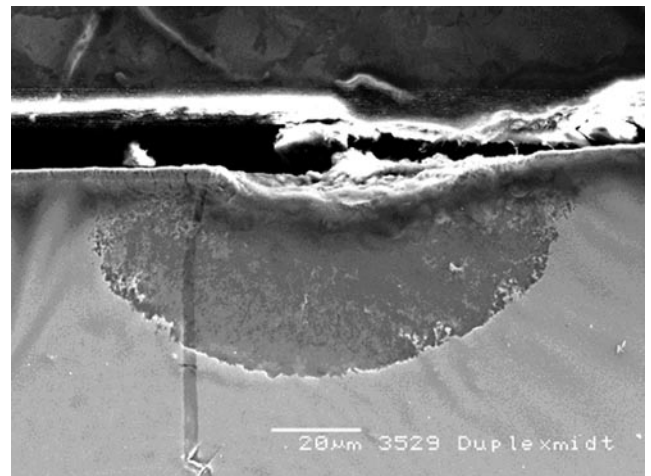
Figure 12—DLC-duplex after erosion-corrosion in 0.05M sodium citrate/citric acid buffer at pH 4 with a NaCl concentration of 0.5 wt%, showing under-corrosion of the conventional nitrided stainless steel substrate.

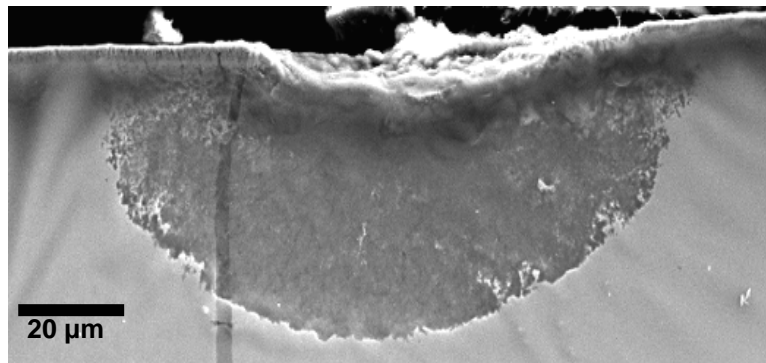
Fig. 1. DLC-duplex after erosion-corrosion in 0,5 wt.% NaCl, pH 4, showing under-corrosion of a conventionally nitrided stainless steel substrate [6].

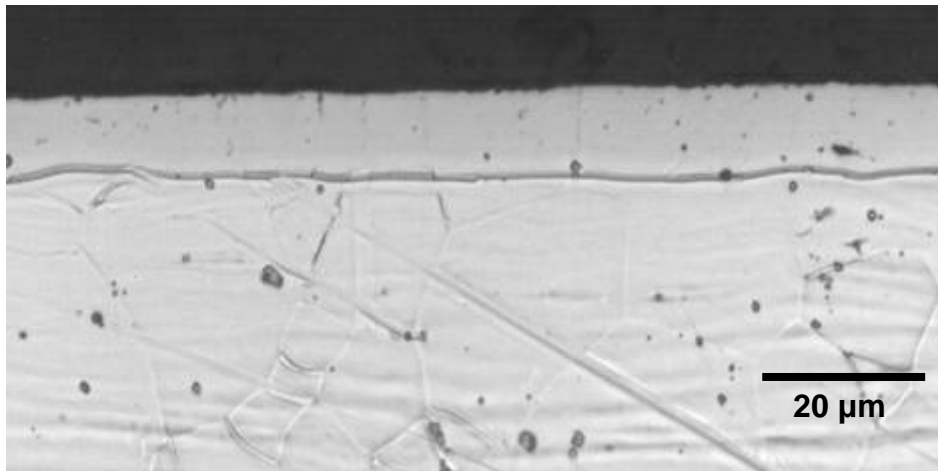
Fig. 2. Low temperature nitrided AISI 316 L.

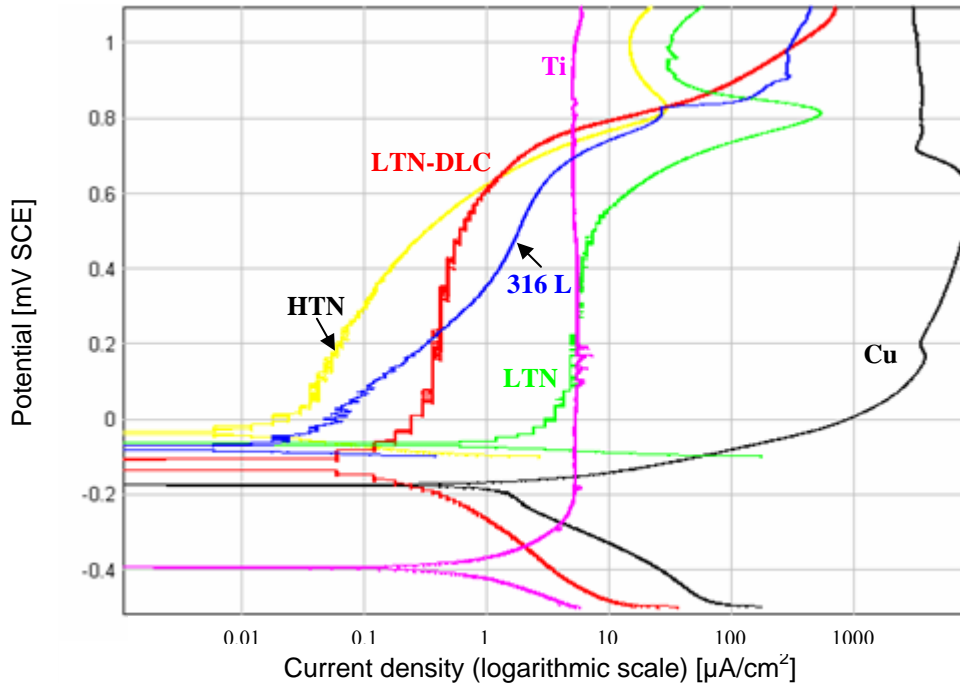
Fig. 3. Polarization curves at a scan rate of 30 mV/min in 0,5 wt.% NaCl, 0,1 M sodium citrate/citric acid buffer at pH 4,0.

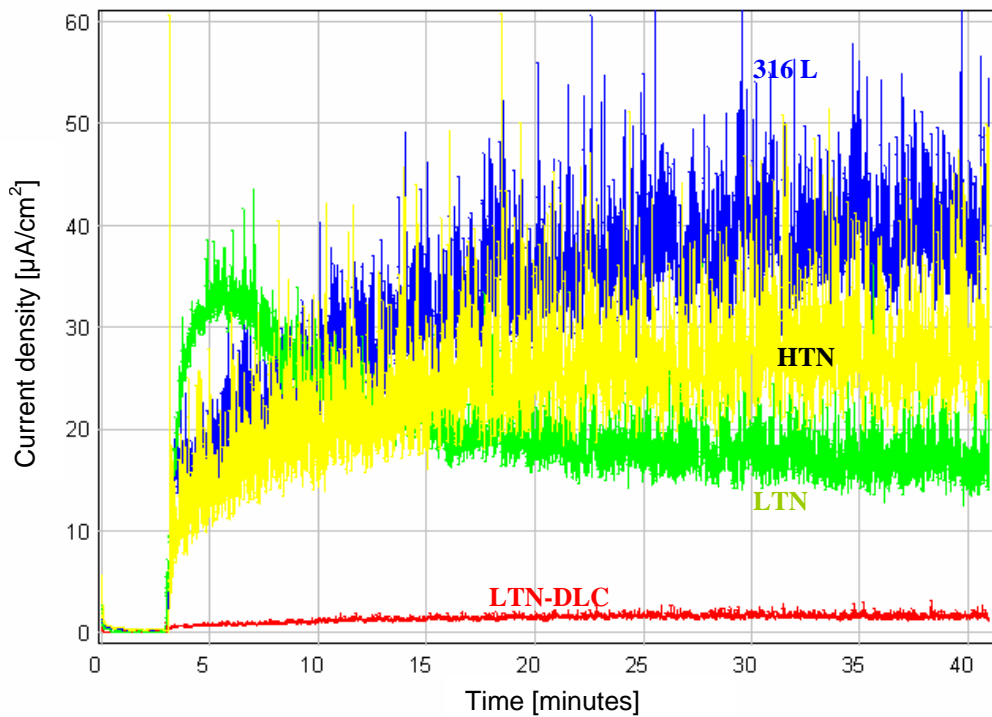
Fig. 4. Current density monitored in 0,5 wt.% NaCl for untreated, LTN, HTN, LTN and DLC coated AISI 316 L exposed to erosion from 3 to 41 minutes with 1,9 g/l Al_2O_3 at 644 mV SHE. Not shown are curves for Ti with similar current density values as HTN. The current density for Cu was in the range of several mA and neither shown.

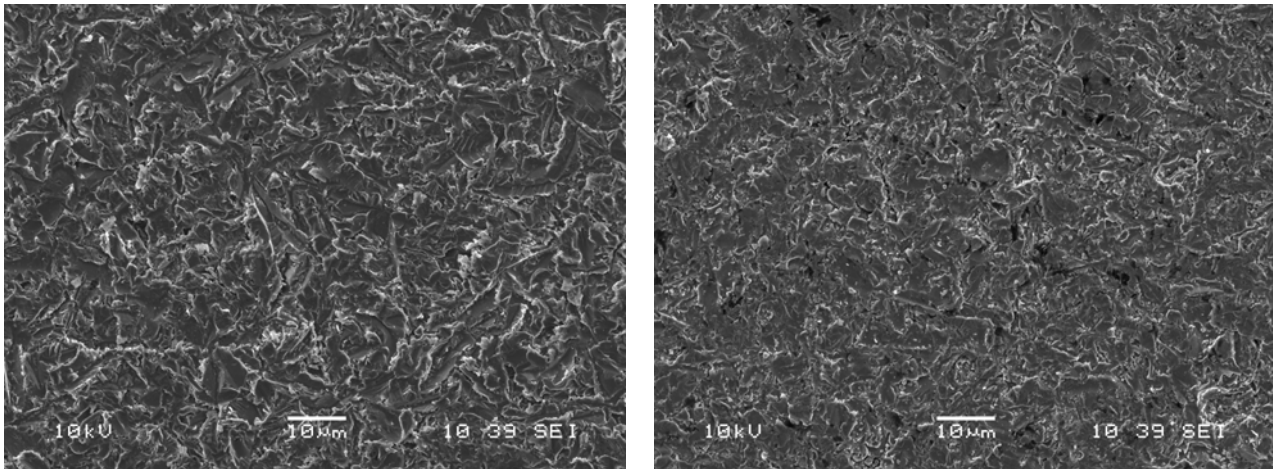
Fig. 5. Scanning electron microscopy surface analysis on AISI 316 L untreated (to the left) and LTN (to the right) after 38 min exposure to erosion–corrosion with 1,9 g/l Al_2O_3 at 644 mV SHE in 0,5 wt.% NaCl.

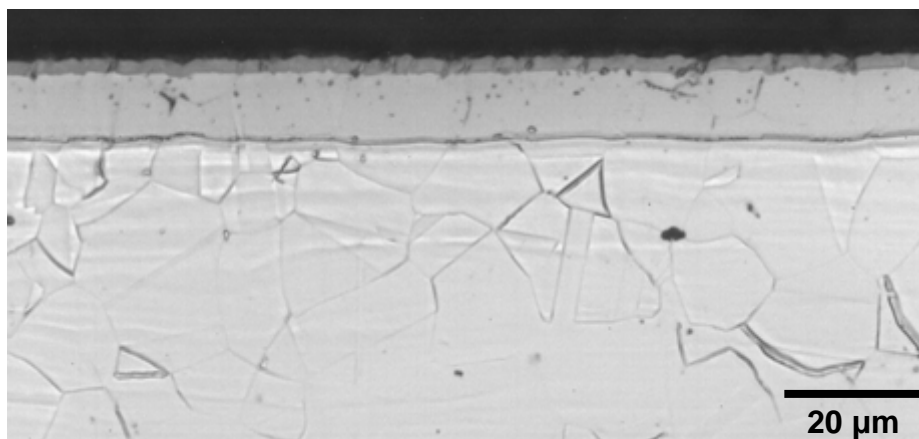
Fig. 6. Micrograph of eroded LTN-DLC.

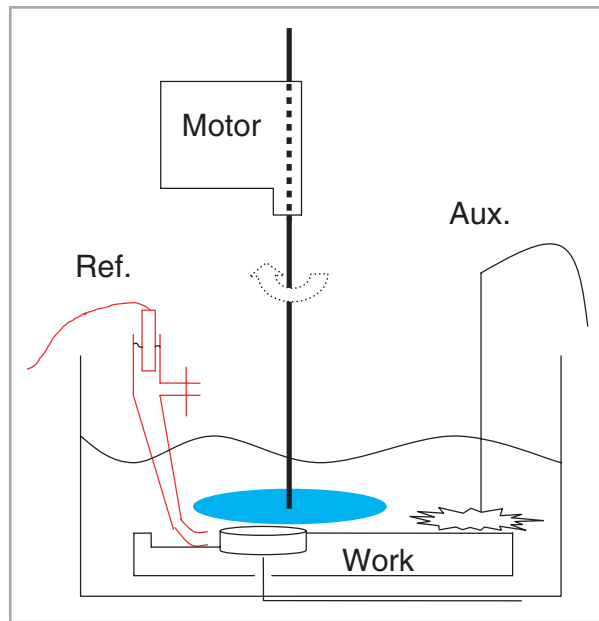
Fig. 1. Tribocorrosion set-up with motor, washable leather, auxiliary (Aux.) and reference electrode (Ref.). The mounted coin acts as the working electrode (Work).

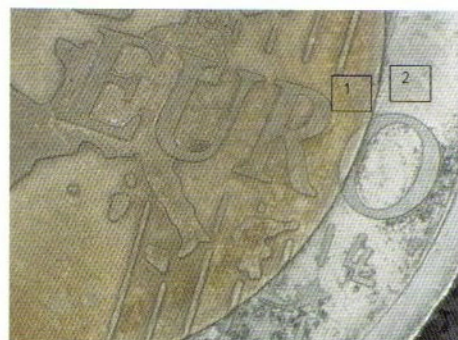
Spectrum wt. %	C	O	Cl	Ni	Cu	Zn
1	3,8	1,5	1,6	23,5	69,5	-
2	6,3	2,8	4,7	4,7	69,5	12,0

Surface analysis carried out by energy dispersive X-ray spectroscopy after tribocorrosion tests, states an increased content of chlorine Cl possibly from an insoluble chemical compound precipitated on the surface. Carbon is a light atom and the value is only legitimate as a trace element when found in energy dispersive spectrum analysis. Energy dispersive spectroscopy is only used as a method for qualitatively indicating the presence of species within a penetration depth of approximately 10 μm .

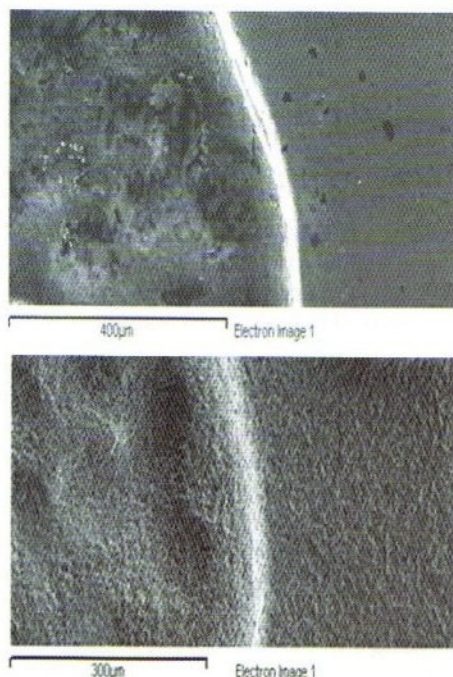
Figure 4: SEM micrographs of a 2-euro coin before tribocorrosion (above) and after tribocorrosion (beneath).

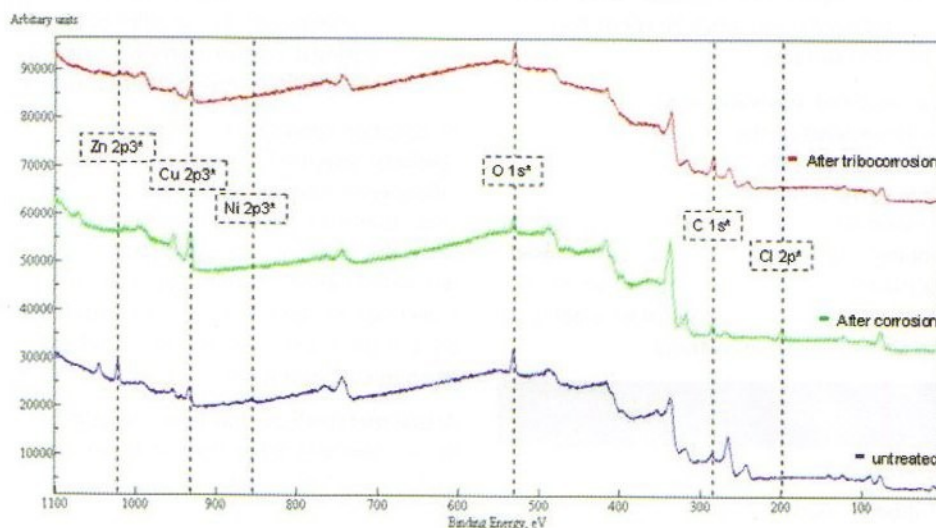
Figure 5: XPS survey scan of the Cu75 Zn20 Ni5 alloy indicating the relevant binding energy peaks of main elements present on the surface. The untreated coin has been polished with SiC grit 500, washed with distilled water and dried.

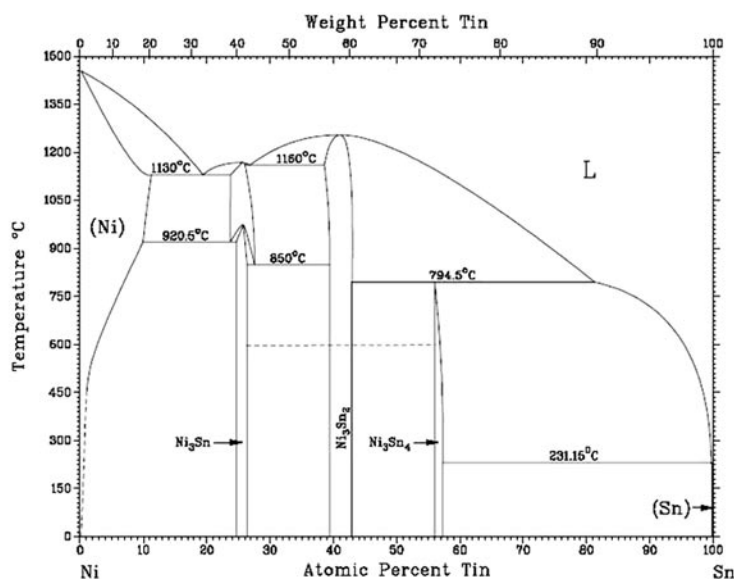
Figure 1—NiSn phase diagram.²

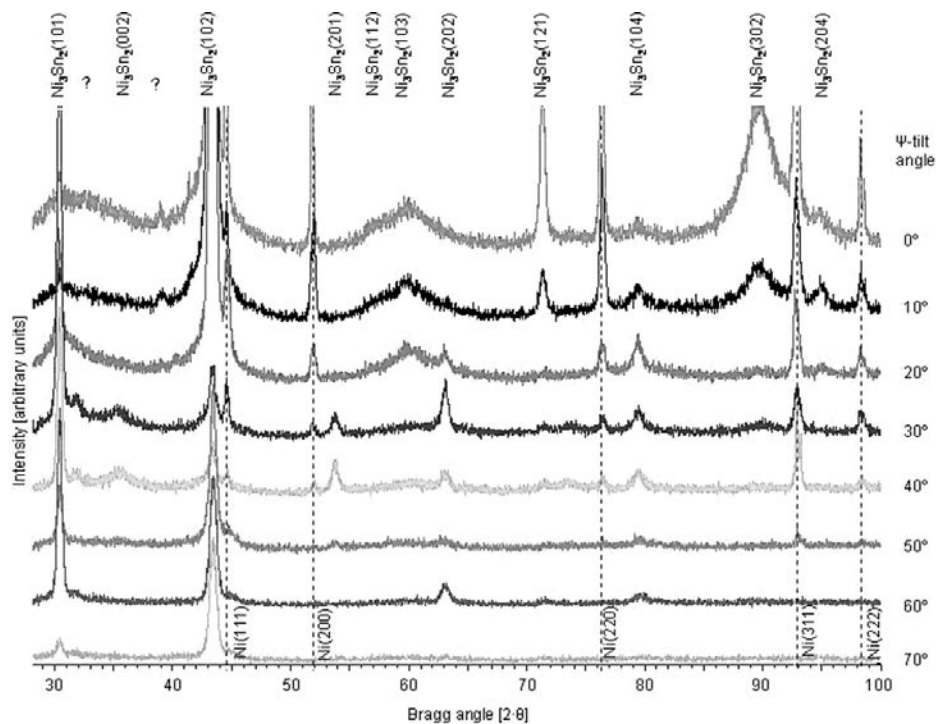
Figure 2—X-ray diffraction patterns (CuK α) of electrodeposited NiSn on a nickel substrate. The scan is repeated for eight different tilt angles. Nickel peaks from the substrate are marked with dotted lines.

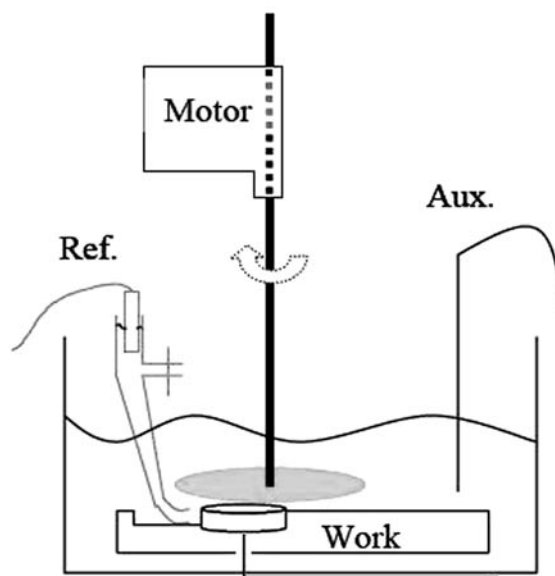
Figure 5—Tribocorrosion setup with motor, washable leather, auxiliary and reference electrode. The mounted sample acts as the working electrode.

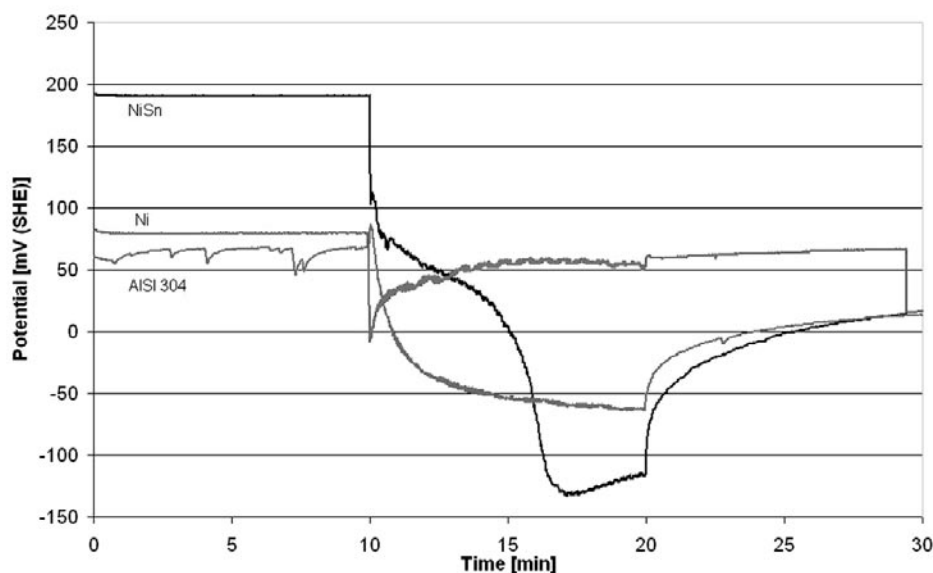
Figure 6—Open circuit potential measurements for NiSn, nickel and AISI 304 with and without the influence of wear. The open circuit potential was measured for 10 min and then the washable leather rotation was started. The rotation was stopped after 20 min.
